## Makina dairelerinden kaçış

## Escape from machinery spaces

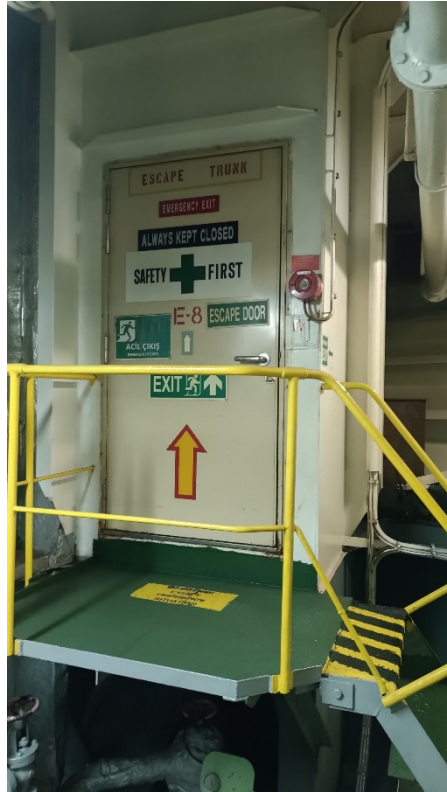
IACS UI SC276&277 (IACS Üye Klas Kuruluşları için 1 Şubat 2016 veya sonrasında inşa sözleşmesi yapılan gemiler için geçerlidir) aynı yorumu sağlarken, pratik zorluklar hala devam etmektedir. Yapısal kısıtlamalar bazen ideal kaçış tranki yerleşimini engelleyerek denetimler sırasında eş yoruma uymakta tutarsızlığa yol açmaktadır.

SOLAS kural II-2/13.4.1 ve 13.4.2, makina mahallerinden iki bağımsız kaçış yolu gerektirir; bunlardan biri mahalın alt kısmına kadar uzanan korumalı bir muhafaza olmalıdır. "Alt kısım (lower part)"ın eş yorumu, MSC.1/Circ.1511/Rev.1 ile açıklığa kavuşturulmuştur ve makina mahallindeki en düşük güverte seviyesi, platform veya geçit olarak tanımlanmıştır.

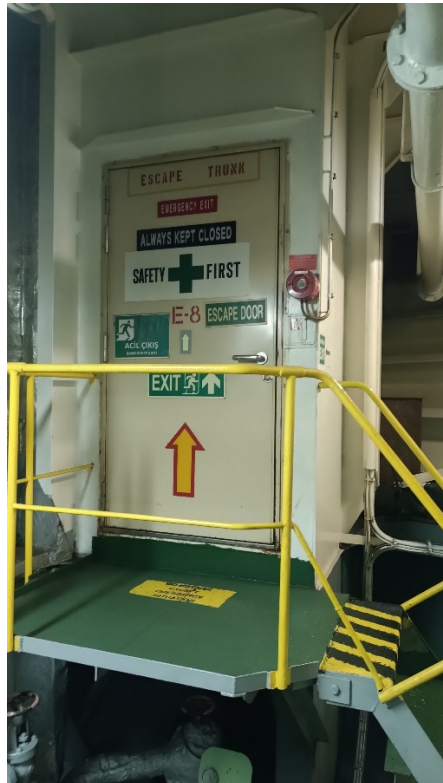
While IACS UI SC276&277 (applicable to ships contracted for construction on or after 1 February 2016 for IACS Member Class Societies) provide the same interpretation, practical challenges still persist. Structural constraints sometimes prevent ideal escape trunk placement, leading to inconsistent compliance interpretations during inspections.

SOLAS regulations II-2/13.4.1 and 13.4.2 require two independent escape routes from machinery spaces, with one being a protected enclosure extending from the lower part of the space. The interpretation of "lower part" has been clarified through MSC.1/Circ.1511/Rev.1, defining it as the lowest deck level, platform or passageway within the machinery space.
